AL NAHRWAN  
WATER SUPPLY PROJECT  
AL NAHRWAN, IRAQ

**SIGIR PA-05-003**  
**MARCH 15, 2006**

## **Al Nahrwan Water Supply Project**

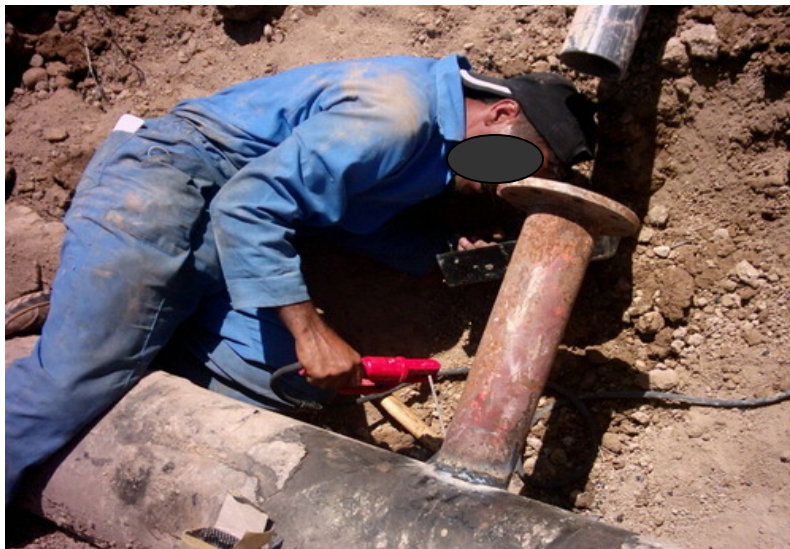
According to the USACE quality assurance reports and contractor quality control reports, piping and fittings arrived on site on March 26, 2005 and were inspected by the USACE QAR on March 28, 2005. Excavation of the pipeline began March 26, 2005. Installation of the connecting flange to the 450 millimeter water main was accomplished on April 3, 2005 (Site Photo 1<sup>1</sup>). The pipeline was then installed with a sand base in the excavated trench (Site Photo 2) and the trench was backfilled. The contractor quality control reports, USACE QAR reports, material list, and photographs appear consistent with the contract and design requirements.

**Photo 1: Installation of connecting flange to the 450 mm water main**

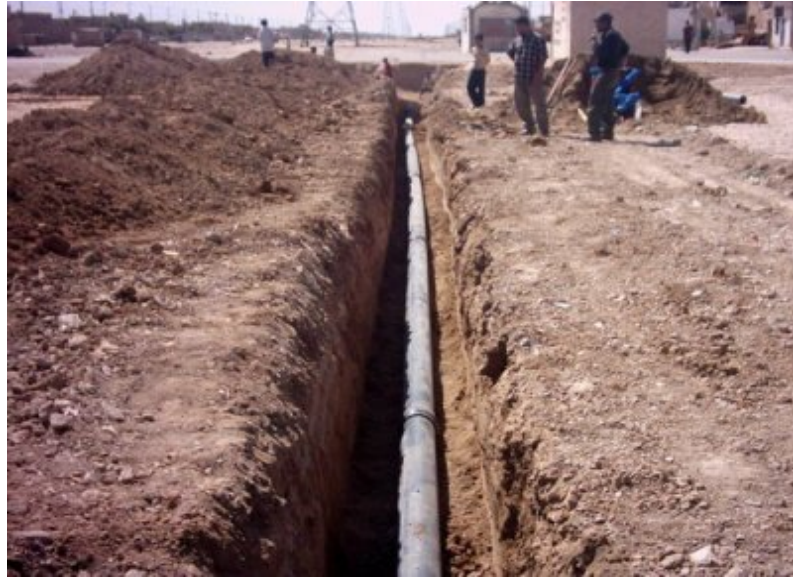
The contract and design specifications required the supply and installation of approximately 1500 meters of 200 millimeter (8 inch) UPVC to connect an existing 450 millimeter (18 inch) water main to an existing housing area. This work required the excavation of a trench, placement of a sand base, installing the pipe, connecting the 200 millimeter new pipe to the 450 millimeter existing water main, and then backfilling and grading.

**Photo 2: Installation of 200 mm UPVC pipeline**

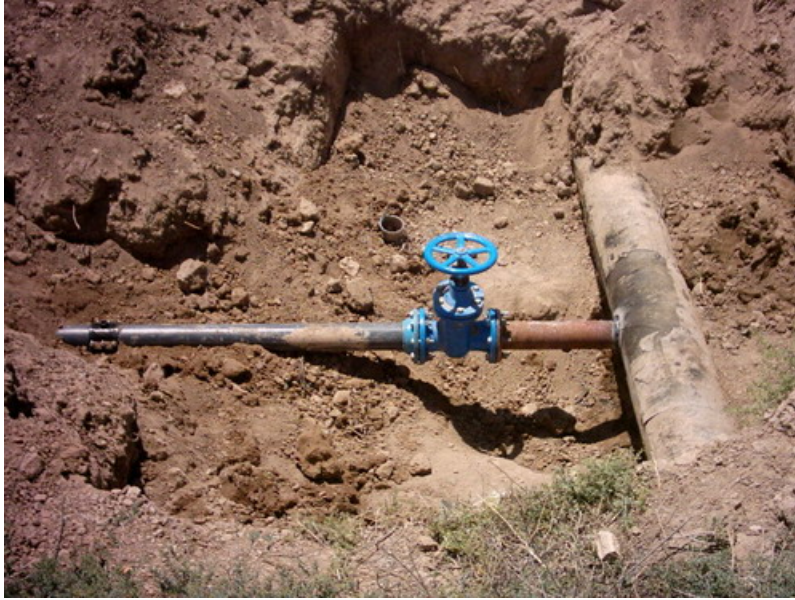
The contract and design required approximately 100 meters of 110 millimeter (4 inch) UPVC pipe and fittings be supplied and installed. The requirement was to connect a 300 millimeter (12 inch) existing water main to the new 200 millimeter water pipe in order to equalize the high pressure city water system with the low pressure system and to complete a closed loop system.

According to the USACE quality assurance reports and contractor quality control reports, the materials arrived on site on March 26 and 28, 2005, and were inspected by the USACE QAR on March 28, 2005. Excavation required for the installation of the pipe was initiated May 19, 2005, and the placement of the pipeline and connections and backfilling was completed on May 22, 2005 (Site Photo 3). The

**Photo 3: 110 mm connection to 300 mm existing pipe**

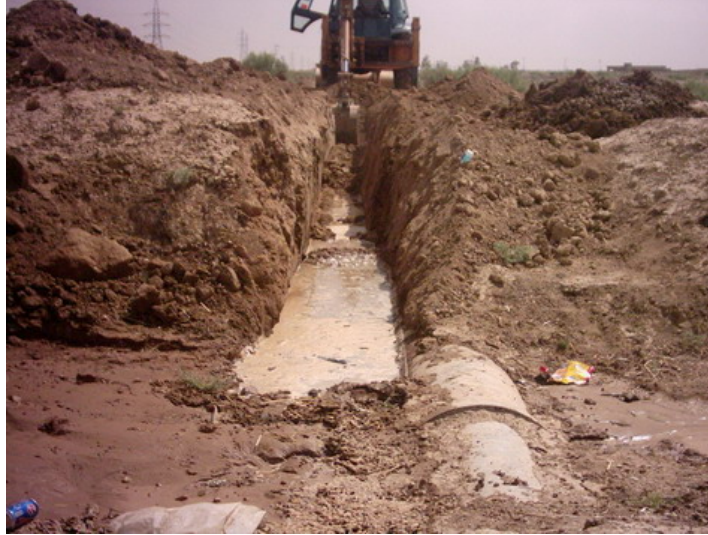
Excavation, illegal connection removal, repair of pipeline, and backfilling was accomplished between June 13 and 16, 2005 (Site Photos 4 through 7). In excess of 159 illegal connections, ranging in size from ½ inch to 4 inch, were identified and removed along a 963-meter length of the water main. The contractor quality control reports, USACE QAR reports, and photographs appear consistent with the contract and design requirements.

**Photo 4: Excavation to locate illegal connections**

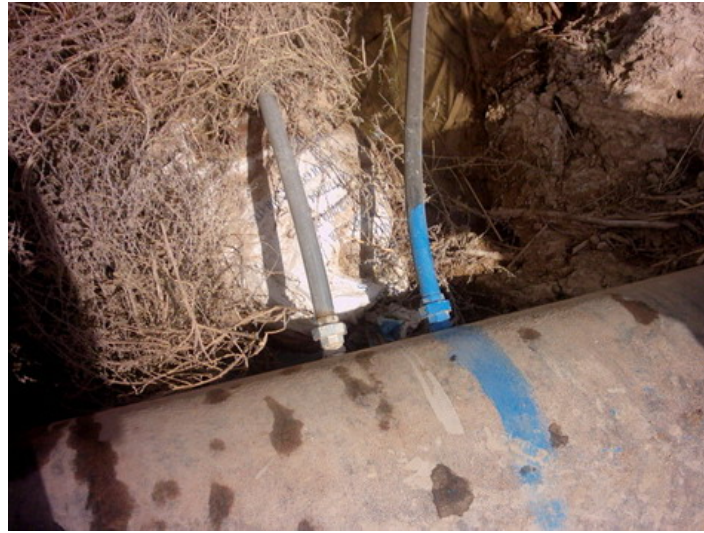
The contract and design required the excavation of a 600 millimeter (24 inch) water main, disconnection of the illegal connections, repairing the pipeline and backfilling. The water main extended from a water pump station to the City of Al Nahrwan and ran through four villages. The illegal connections were of poor quality, producing numerous leaks from the water main.

**Photo 5: Illegal connections**

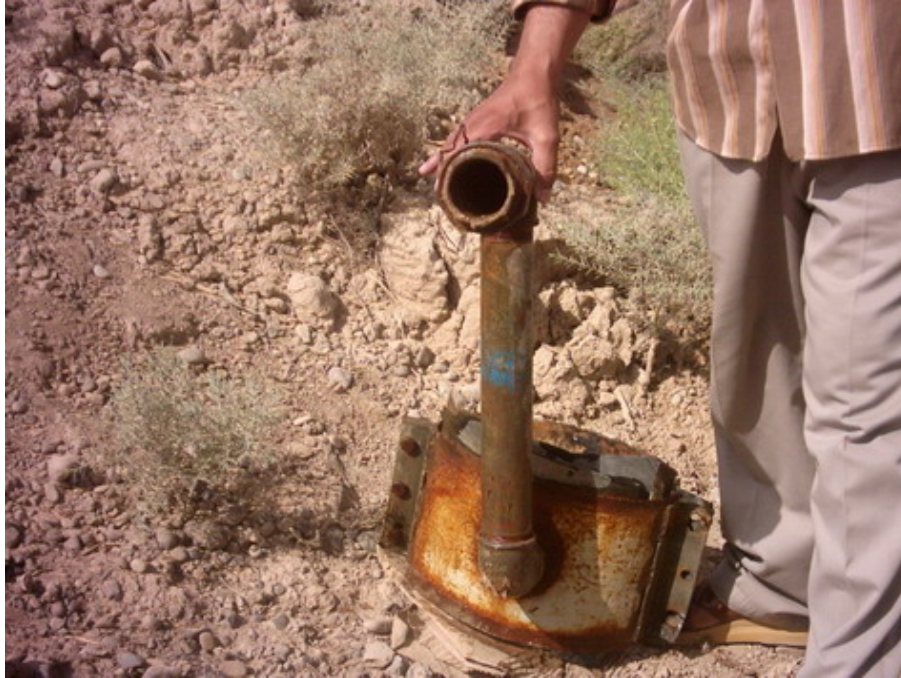
**Photo 6: Illegal connection (saddle used to tap into water main)**

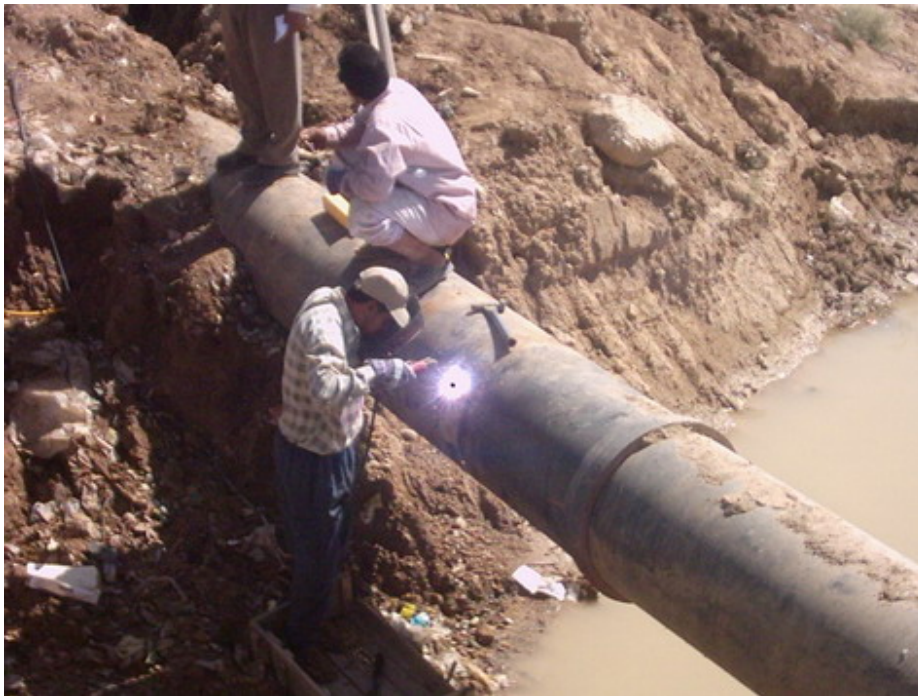
**Photo 7: Repair of water main after disconnecting illegal connection**

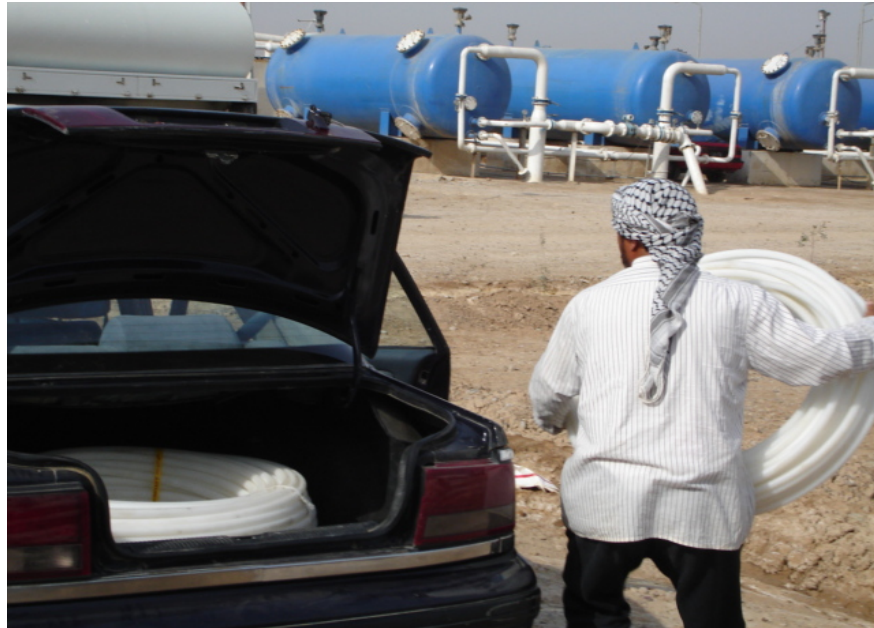
According to the USACE quality assurance reports and contractor quality control reports, the house connections were completed May 12 through May 18, 2005 (Site Photos 8 and 9). The contractor quality control reports, USACE QAR reports, material list, and photographs appear consistent with the contract and design requirements.

**Photo 8: Arrival of 15 millimeter water line used for house connections**

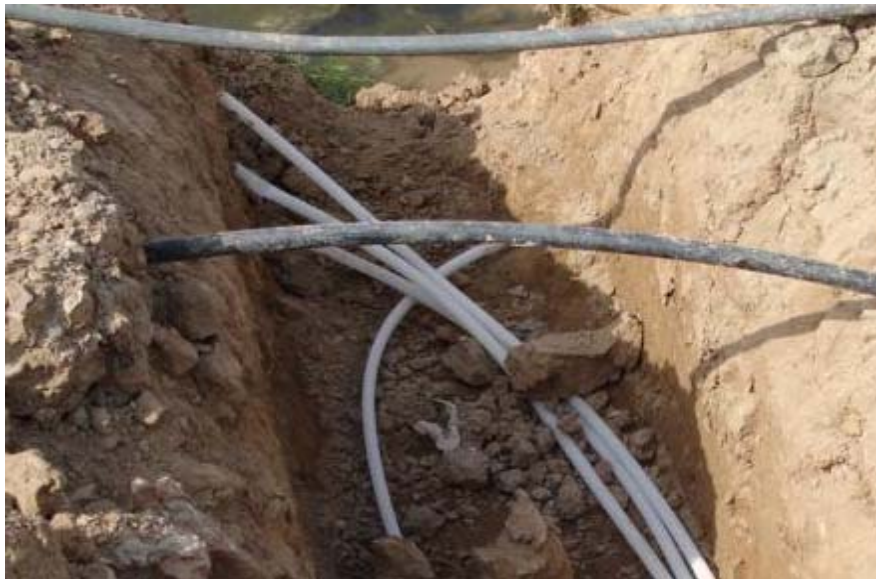
**Photo 9: Placement of 15 millimeter water lines in excavation**
